Sustainable Architectural Restoration of Heritage Villages in Jordan

Salma George Egho ^{1*} | Hanan M. Ahmad Jumaily ²

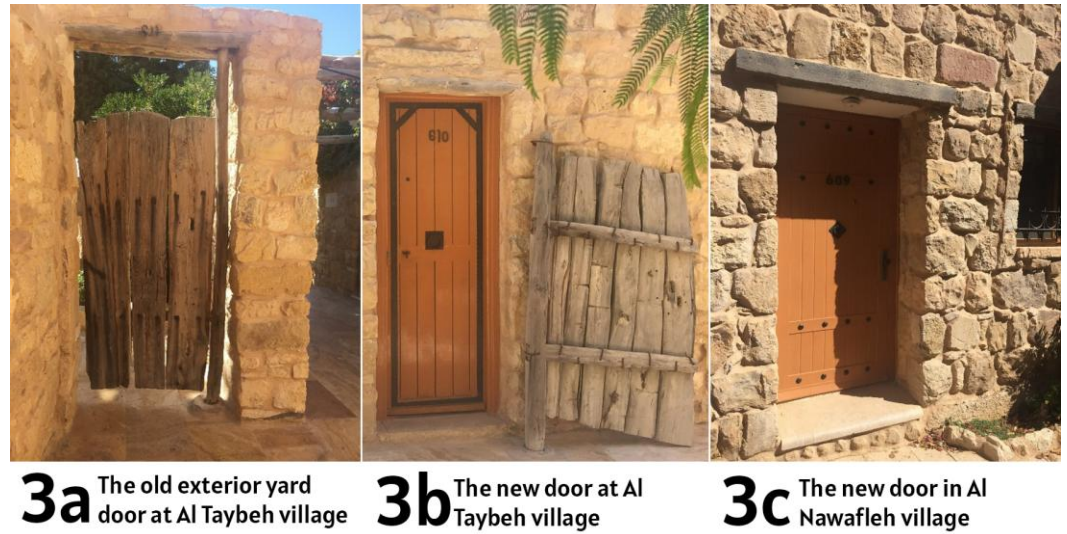
Figure 3. old and new doors in the villages of Al Taybeh and Al Nawafleh

The main entrances in both case studies were made of wooden doors from Juniper trees, which are dominant in the Petra area (Abu-Darwish et al., 2014). While some old entrance doors in the houses of Al Taybeh still exist, most of them have been replaced with new doors made of Swedish wood (Table 1).

Interestingly, only 13.6% of entrance doors in Al Taybeh are original, whereas all entrance doors in Al Nawafleh have been replaced with new ones. As for the internal doors in both villages, some of them have been replaced with modern doors made of Swedish wood. Figure 3 presents site photos of the village doors, taken by the author.

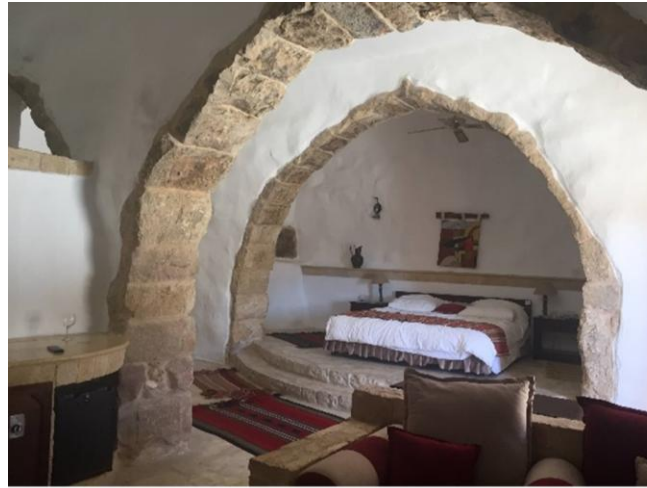
5a Arches in the houses of Al Taybeh village

The number of arches in houses varies across the two studied villages. For instance, the village of Al Taybeh has houses with up to three arches, while the village of Al Nawafleh has houses with up to two arches. The field study findings indicate that 62% of houses in Al Taybeh village have arches, while in Al Nawafleh village, this percentage is only around 9%.

In both villages, the arches helped divide the spaces of the houses according to their functions, while keeping the total space of each house open to allow the maximum amount of sunlight to enter, thereby reducing the energy used for lighting and heating. These findings agree with Sokienah (2020), who reported that the design of interior spaces and the distribution of functions in traditional Jordanian houses had a positive sustainable effect in reducing energy consumption. The characteristics of the arches in the studied villages, including the restoration procedures applied to sustain them, are listed in Table 3.

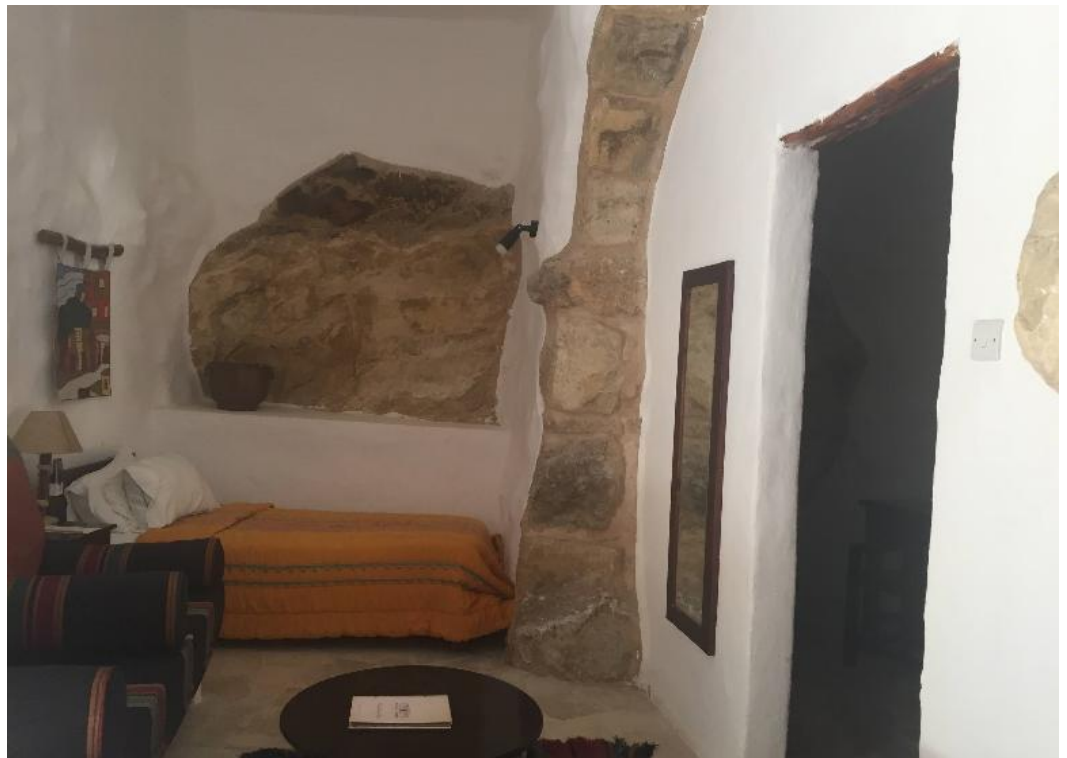
Figure 6. The oldest house in Al Taybeh village (House number 308)

It is evident that the native inhabitants of these villages constructed their homes based on practical experience accumulated over time. The oldest house in Al Taybeh village (house number 308, Fig. 6) features irregularities in its architecture, including the walls, the arch with an irregular shape, and the main door, which has varying dimensions (100 cm at the bottom and 80 cm at the top). In contrast, the houses built later exhibit more precise dimensions for their architectural elements compared to the oldest ones.

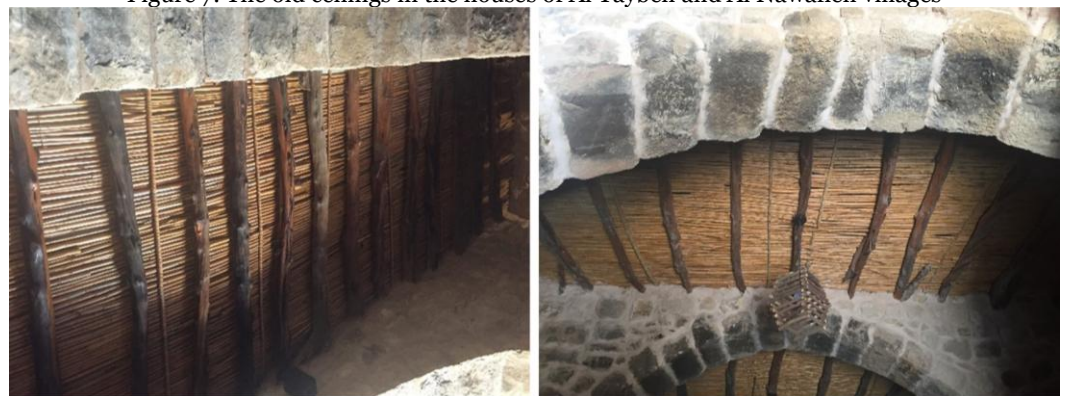
Figure 7. The old ceilings in the houses of Al Taybeh and Al Nawafleh villages

In Al Taybeh village, the roofs of 25 houses were rehabilitated using traditional methods, while 100 other houses had their ceilings restored with reinforced concrete, which was later plastered and painted. In contrast, in Al Nawafleh village, only five houses had their ceilings restored using traditional methods. To preserve the traditional forms of the ceilings in the remaining 133 houses, a new method was employed. The rehabilitated ceilings were roofed with concrete as the upper surface, which was then covered by a mixture of mud and straw. The internal side of the roofs was covered with Juniper trunks (Figures 7a and 7b). Furthermore, due to the lack of long horizontal wooden struts, the ceilings were internally covered with short Juniper horizontal struts fixed with iron beams, whose direction was opposite to that of the flat wooden struts (Figures 7a and 7b).

7a The old ceilings in the houses of Al Taybeh village

7b The old ceilings in the houses of Al Nawafleh village

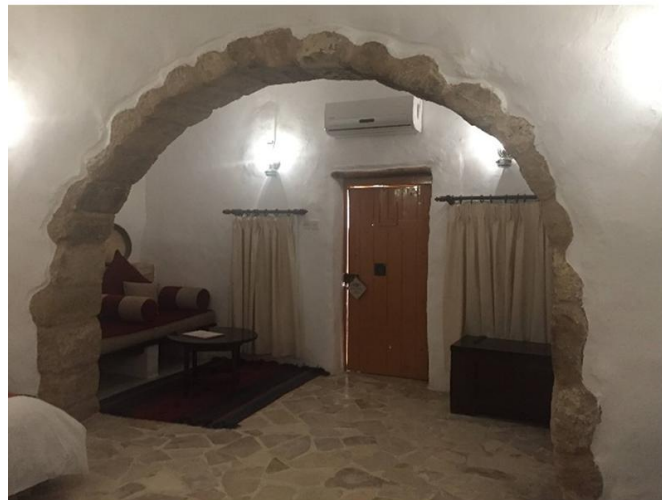
9a Al Taybeh village

- a) Using the procedure of cladding stone walls with plaster and then painting over them to break the monotony of repeating stone goes against Article 9 of the Venice Charter. This article emphasizes the importance of specialized restoration processes that aim to preserve and reveal the aesthetic and historical value of antiquities while conserving the original materials and structures. Figures 9a and 9b show onsite photographs taken by the author, highlighting the disadvantages observed in Al Taybeh and Al Nawafleh villages.

Figure 9. Disadvantage A: Cladding stone walls with plaster and then painting over them in Al Taybeh and Al Nawafleh villages

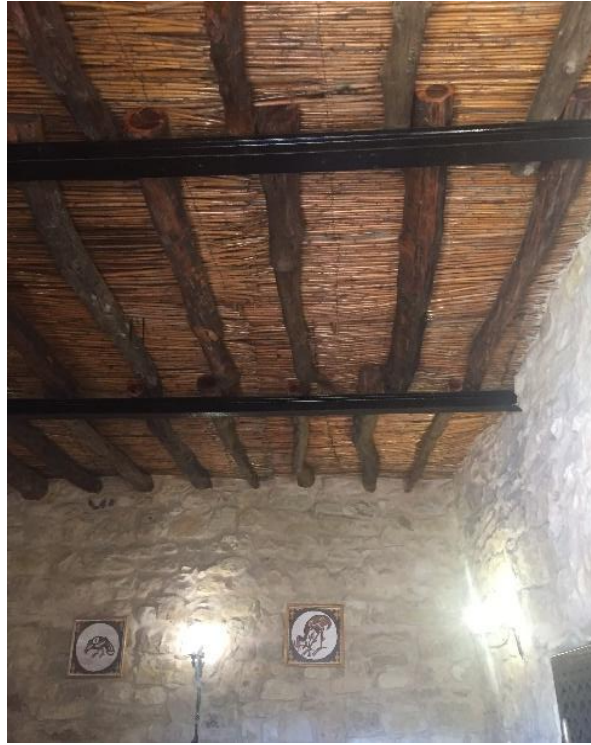
original material of the roof and distorts the aesthetics due to the placement of the iron beams. Additionally, this method contradicts the principles for the preservation of historic timber structures adopted by ICOMOS in 1965 (Aslan et al., 2023). According to Article 9 of these principles, when repairing a historic structure, replacement timber may be used, but only with due respect to the relevant historical and aesthetic values. It also states that when replacing decayed or damaged members, or restoring them, new members or parts should be made from the same species of wood with the same or, if possible, better grading than the original members. The replacement timber should also have similar natural characteristics, and other physical characteristics should be compatible with the existing structure.

Figure 10. The disadvantage in the ceiling restoration of some houses in Al Taybeh village

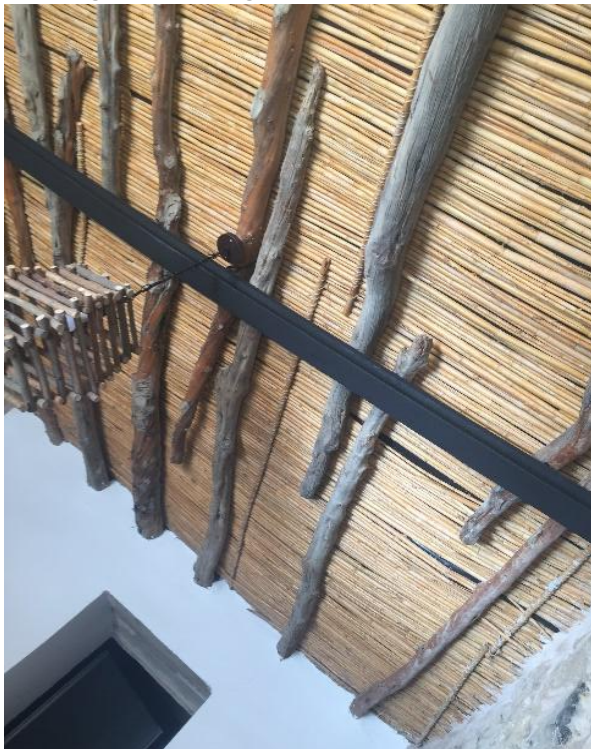
Figure 11. The disadvantage in the ceiling restoration of some houses in Al Nawafleh village

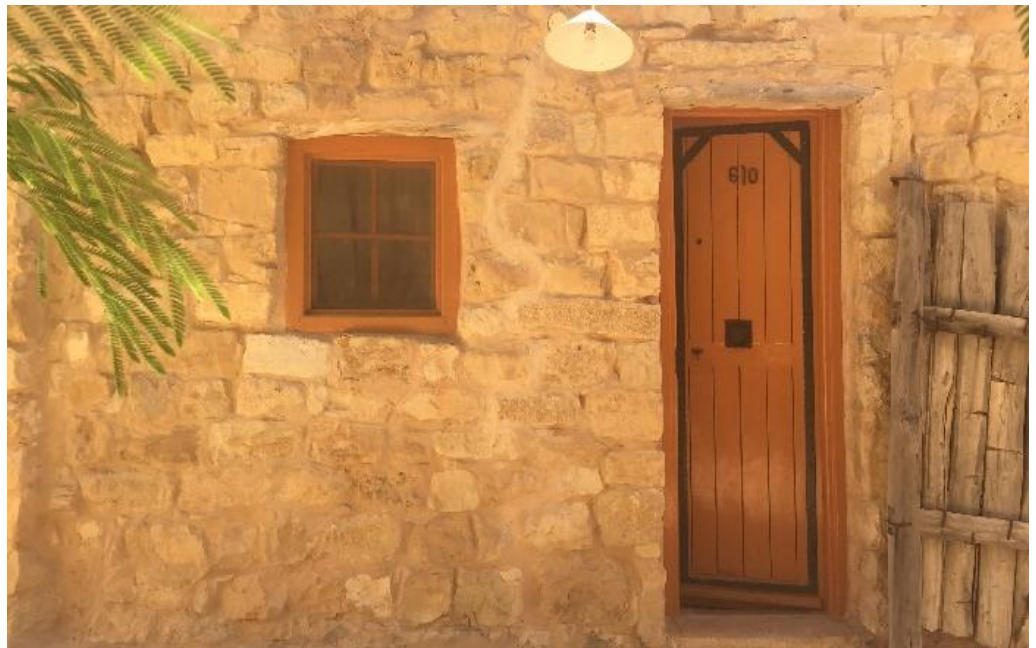
- c) One of the downsides of the method used to restore the houses in the two villages was the replacement of the traditional joint in all the walls with solid cement mortar (Kohal), which violated Article 9 of the International Charter for the Conservation and Restoration of Monuments and Sites (Venice Charter), which states that: 'The process of restoration is a highly specialized operation. Its aim is to preserve and reveal the aesthetic and historic value of the monument and is based on respect for original materials and authentic documents' (ICOMOS, 2023). This process could harm the integrity of the stones, as they are weaker than cement mortar. If the houses are exposed to external factors such as earthquakes, the stones could be affected and damaged (Figure 12 and Figure 13).

Figure 12. Disadvantage C: The replacement of the traditional joint with solid cement mortar in Al Taybeh village

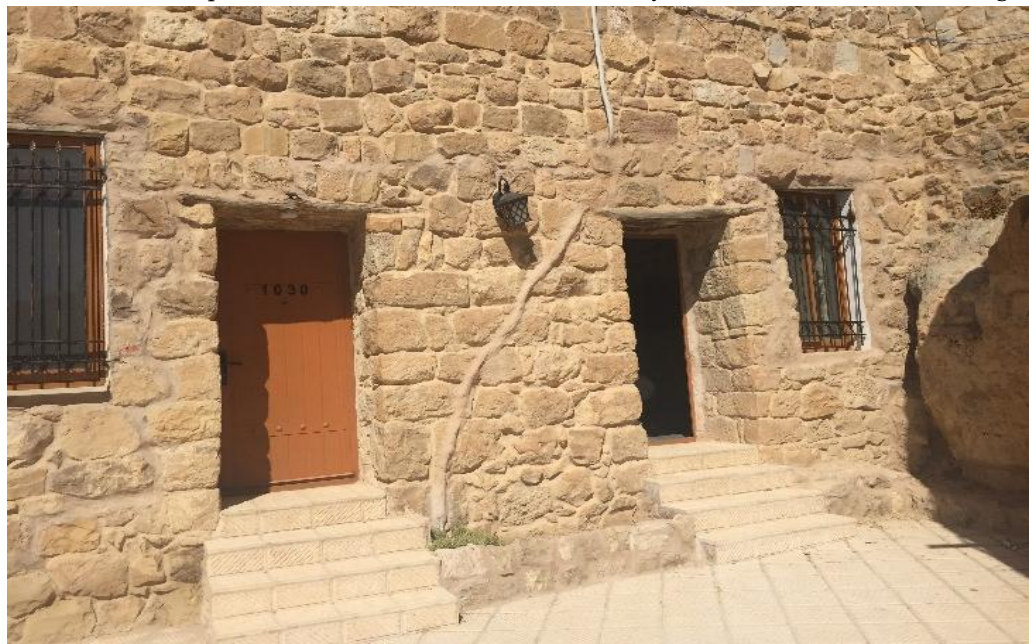
- d) In the two studied villages, some houses had electrical extensions that were not concealed within the stones of the building's façade. These extensions were installed in a haphazard and distorted manner. Such practices violate Article 9 of the International Charter for the Restoration and Maintenance of Historical Sites and Monuments (Figure 13).

Figure 13. Disadvantages C and D: The replacement of the traditional joint with solid cement mortar and the haphazard, distorted installation of electricity extensions in Al Nawafleh village
